PHOTOGRAPHIC ANALYSIS

TRANSMITTER FAULTS

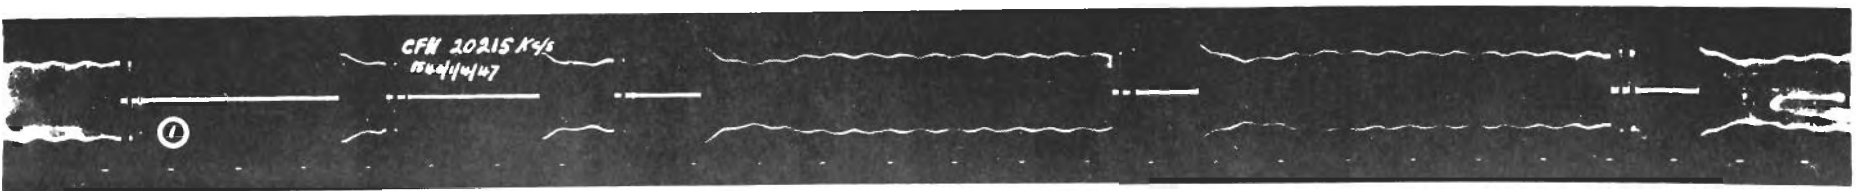
- Photo 1. Spacing bias (space duration of 24 milliseconds instead of 20 milliseconds) with two relay bounces at 3.3 millisecond intervals.
- Photo 2. Series of letter "V", showing a split in the character at a point 6.7 milliseconds along the third unit, possibly due to worn tape or faulty auto-transmitter head.

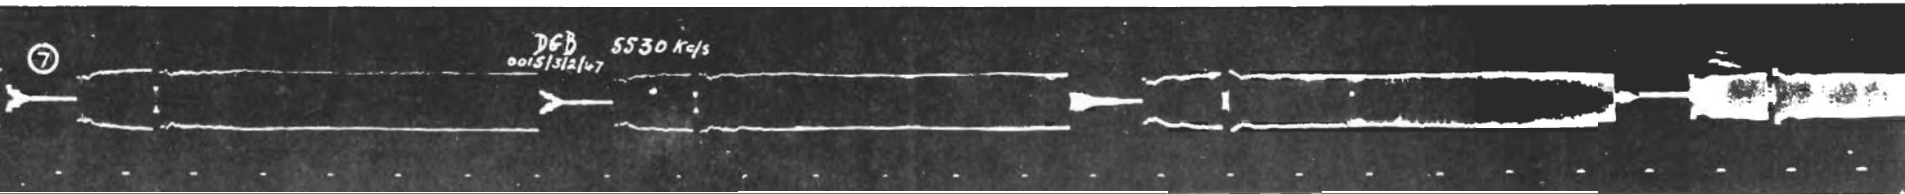
- Photo 7. Photo of H.M.S. VANGUARD's Radio Teletype transmission, showing trace of Multipath and a split in the letter shift character.
- Photo 8. Morse transmission from Malta after keying filter inserted. Deep 100 c/s supply ripple also evident.

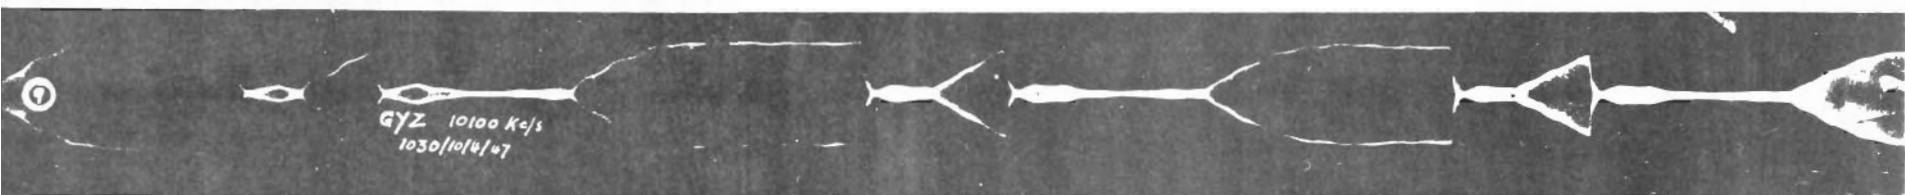
- Photo 9. Series of "N's" in morse. The effect of this particular key click filter is to produce the effect of a spacing bias due to the delay at the commencement of radiation. This can sometimes be reformed by the signal bias adjustment at the receiver - though this is not a very satisfactory method of overcoming the distortion.

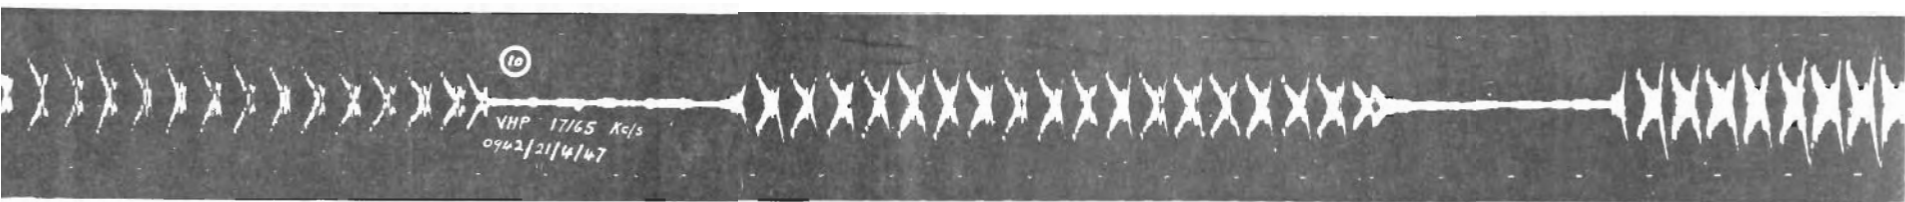
- Photo 10. Morse transmission from VHP. It was understood that the master oscillator was in use at the time. It is possible that the heavy power supply ripple affected the M.O. Evidence of this ripple is also furnished by Photo 11.

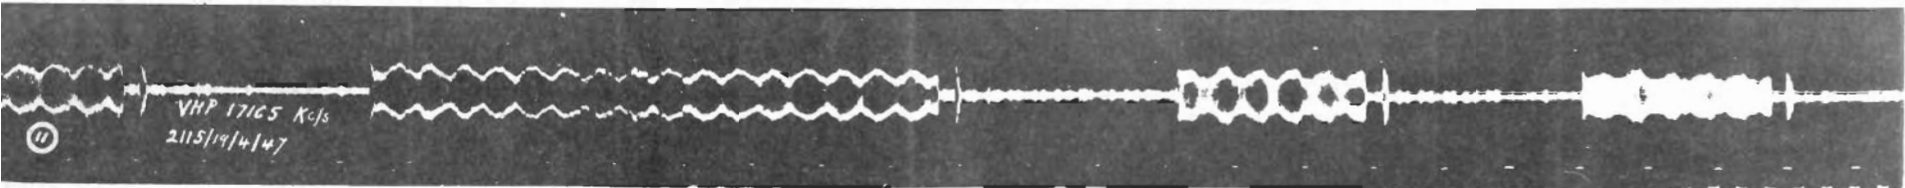
- Photo 11. Shows 100 c/s ripple of power supply along with a single relay bounce.

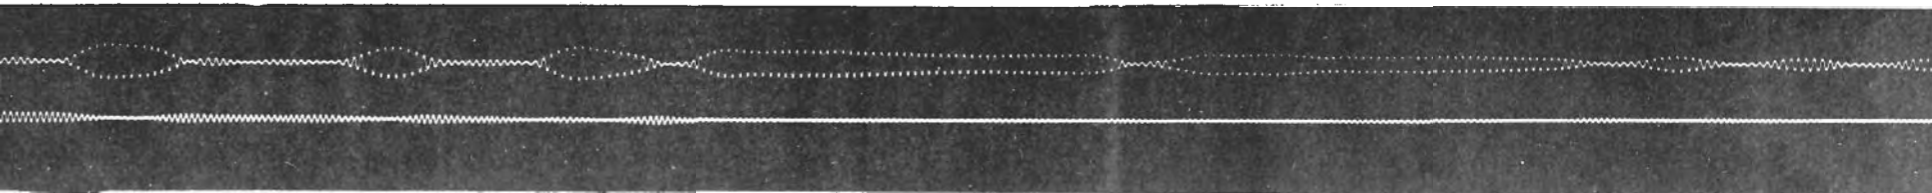
(ONE) M C V F CHANNEL 1 TOP MARK TONE SELECTIVE FADING

BOTTOM SPACE TONE
